## Assessment of Flexible Pavements of the Road System of the Urucu Petroleum Province/Amazonas/ Brazil

**Carlos Fábio Cortezão Carvalho<sup>1</sup>, Anne Karollynne Castro Monteiro<sup>2\*</sup>, Cláudia Ávila Barbosa<sup>2</sup>, Carlos Eduardo Neves de Castro<sup>2</sup>, Consuelo Alves da Frota<sup>2</sup>**

*<sup>1</sup>Petroleo Brasileiro, UO-AM, Manaus, Amazonas, Brazil <sup>2</sup>Research Group in Geotechnics (GEOTEC), Federal University of Amazonas, Manaus, Brazil*

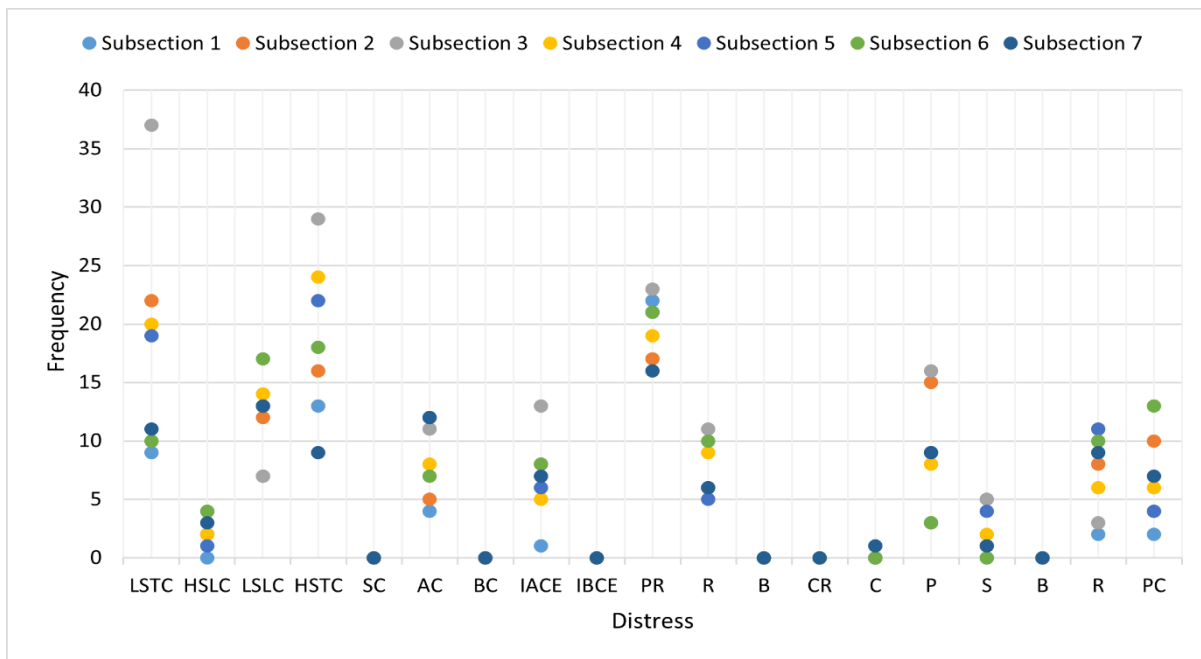
**Figure No. 4: Frequency of distresses**

On the other hand, we tried to highlight the cracks (cracking), Low and High-Severity Transverse Cracking (LSTC and HSTC), Low and High-Severity Longitudinal Cracking (LSLC and HSLC), Shrinkage Cracking (SC), which can be more relevant for the assessment of the paved road. Still, regarding cracking, isolated cracks were not identified, which occurred because of the thermal shrinkage or dissection of the base or coating. Furthermore, interconnected cracks, Block Cracking (BC) and Interconnected Block Cracks with Erosion at the Edges (IBCE) were not found, whose particularity is the formation of rectangular blocks with well-defined sides, caused mainly by the contraction of asphalt coating resulting from the thermal variation. However, cracks classified as LSTC, HSTC, LSLC, and HSLC, as well as groove worn (rutting), registered a high frequency when compared to other types of defects (Figure No. 4).

We emphasize that the consolidated rutting was not identified in the surveyed stations. They are constituted of distresses characterized by permanent deformation, generating a depression in the pavement surface without generating lateral volumetric compensations (uplifting). It should also be mentioned that the depths of wheel tracks did not present values greater than 50mm, except for one station displaying this value exactly.

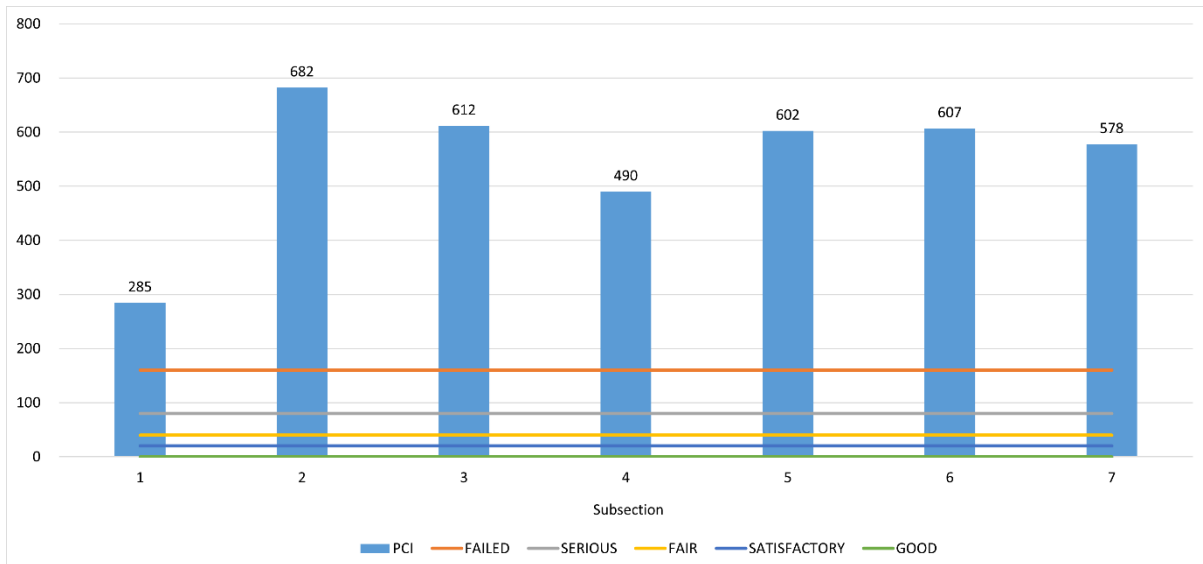
Figure No.5: Defects (pavement distress) along with the subsections

The PCI result is the sum of individual severity indices, composed of the defects found on the pavement surface [9]. In this particular case, the sum of all evaluated subsections resulted in a value greater than 160. Therefore, being considered as failed (Figure No.5) according to the concept that depicts the degree of superficial degradation [5]. This result indicates that the coating has a marked deterioration, with several points that demand immediate restoration.

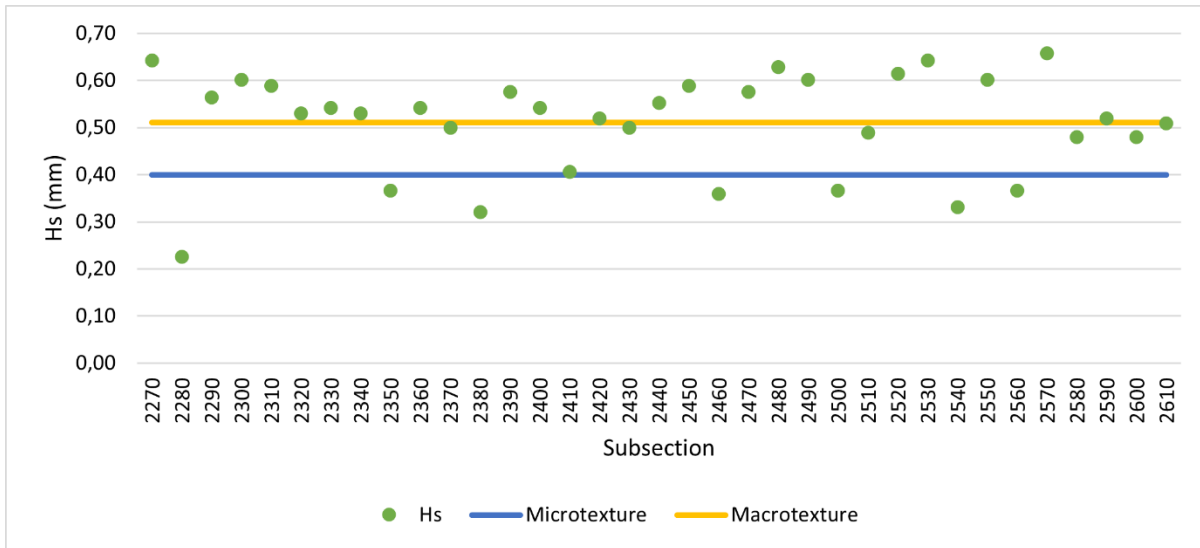
**Figure No.7 - Macrotecture (Hs) along the stretch**

During the experiment, we observed that the section revealed periodic maintenance. Hot Mixed Sand-Asphalt (HMSA) patches were made. Such a solution is identified as a formulation without the presence of coarse aggregates in its composition, which leads to a microtexture to Asphalt Concrete (AC). In determining the average depth of the macrotexture ( $H_s$ ), we proceeded the same way. There was no separation by subsection, that is, all spots were considered. However, in the locations where the replacement of the AC coating with HMSA had been carried out, a reduction in the average of  $H_s$  values is noticed. These different spots are positioned below the line (0.40) (Figure No. 7).

In short, the complete surveyed stretch displayed Hs values ranging between 0.23 mm and 0.66 mm, with a standard deviation of 0.11. That is, within the range of values that corresponds to a texture ranging from thin to average. Using the arithmetic mean of these values (0.51mm), the representative section of an average texture can be measured [6]. Similar results are obtained by disregarding the HMSA-applied sites. Hs results varying between 0.41 mm and 0.66 mm, with a standard deviation of 0.06, and an average of 0.55 mm were identified (Figure No. 8).

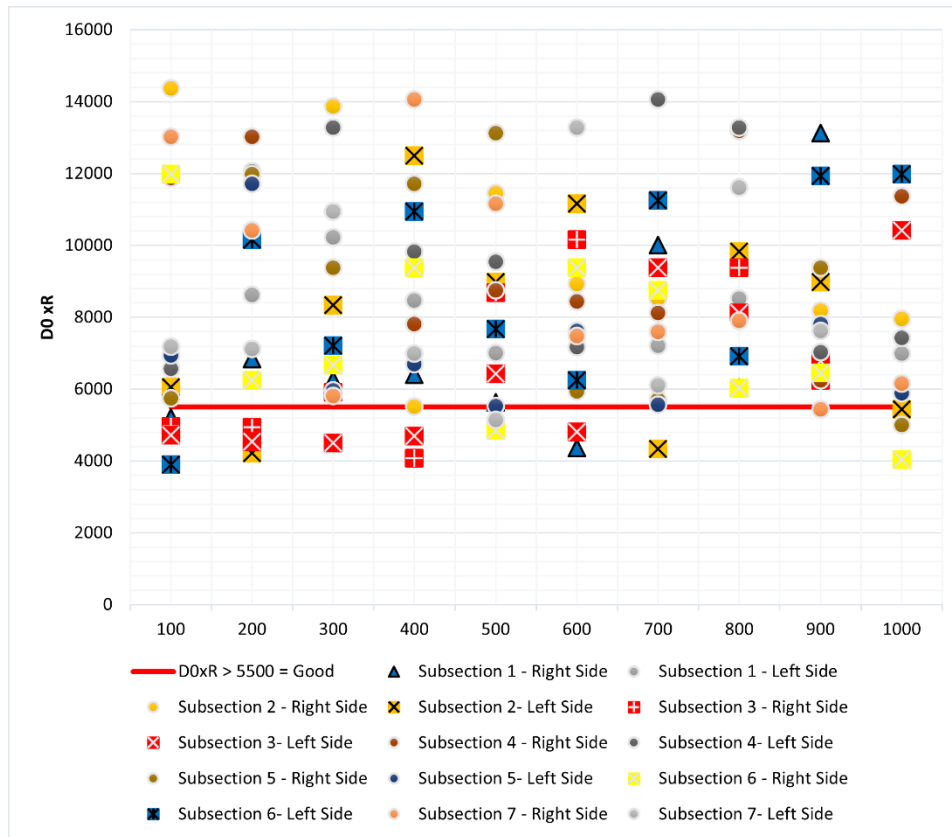
**Figure No. 11:  $D_0 \times R$  relationship along with the subsections.**

As described by Lopes [10], the product of the  $R \times D_0$  ratio is considered as one of the simplest parameters to analyze the structural performance of pavement, with the limit value being 5,500. That is, higher values show structurally acceptable pavements. The results found were satisfactory according to this criterion.

As for the structural condition of the pavement, although the values found in the RxD0 ratio did not prove to be incisive, we concluded that restoration is not necessary for the entire length of the stretch.
