Impacts of Surface Water Mobilization Structures on the Dynamics of Waterbodies and Vegetation in the Maggia Watershed in Niger

Niger has experienced a series of droughts season that have severely impacted natural resources. To respond to this disaster, the country has turned towards the implementation of structural developments in the watershed. The objective of this study is to evaluate the impacts of developments on waterbodies and vegetation dynamics. In addition to population data, this study used climate data, and multi-dated landsat images. The methodology consisted of field surveys of 130 farmers in order to collect their perception on the problem. These surveys were complemented by an inventory of surface water mobilization structures, an analysis of climatic parameters and land use mapping of the valley. Dams and spreading thresholds are the main hydro-agricultural developments identified in the Maggia Valley. More than 90 % of the respondents say that these developments have had a positive impact on the dynamics of the basin's vegetation. For climatic parameters, they show an upward trend over almost the entire period of study. Land use has changed, first with the degra

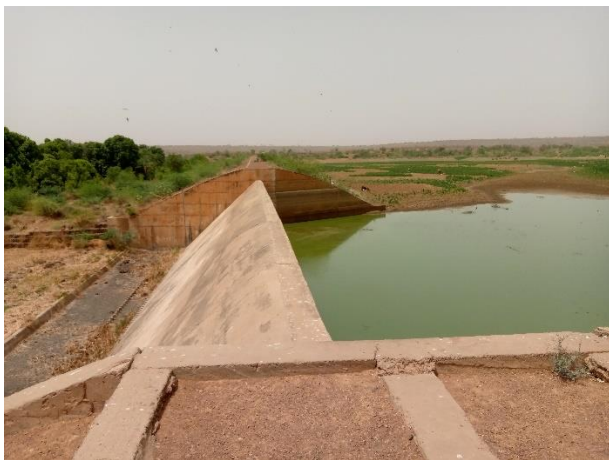
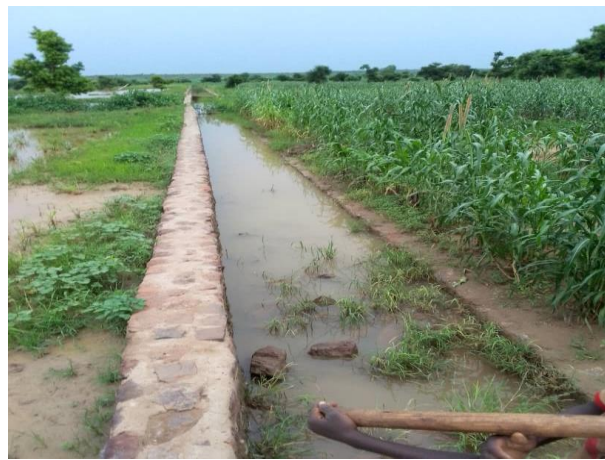
Figure 2. surface water mobilization structures

a. Guidan Magagi Dam (05/08/ 2024)

b. Threshold 2 Balgaya (08/10/2024)

All farmers surveyed stated that the watershed has changed over time. In addition, according to the same actors, sediment deposits are also found at the thresholds with a reduction in their height. Also, structures such as the thresholds that are completed 4 years ago have contributed to the reduction of the flow of the Maggia. The 85 % of farmers who testify that the level of the water table has risen against a decrease in floods compared to the period before the developments. For surface water mobilization structures, two (2) types (Figure 2) have been identified in the valley. Thus, a total of fourteen (14) structures including six (6) dams and eight (8) spreading thresholds were identified. They are mainly built on the minor bed and the tributaries of the Maggia (Figure 3). Dams are the oldest structures in the Maggia. However, the achievement of the application thresholds is concentrated on the period 2000-2020 (Table 1).

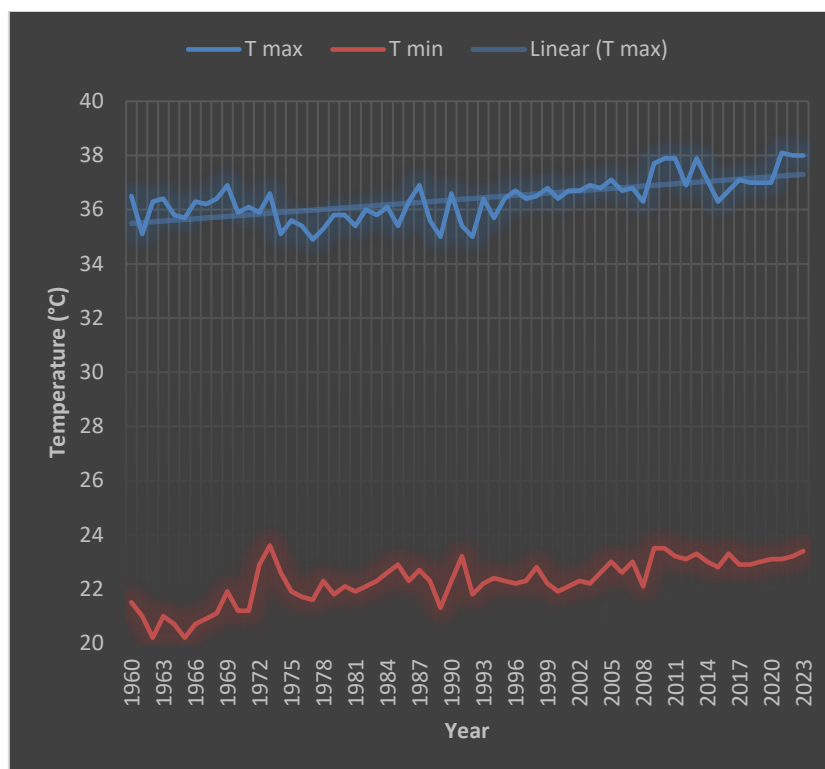
The variation in maximum and minimum temperatures is shown in Figure 6. The two (2) curves are almost uniform over the period 1960-2017. For the period 2018-2023 there is a difference, the minimum temperature increases while the maximum temperature evolves like a sawtooth. Both the maximum and minimum average temperature have an increasing trend.

Figure 6. Variation in temperatures in the valley [15]

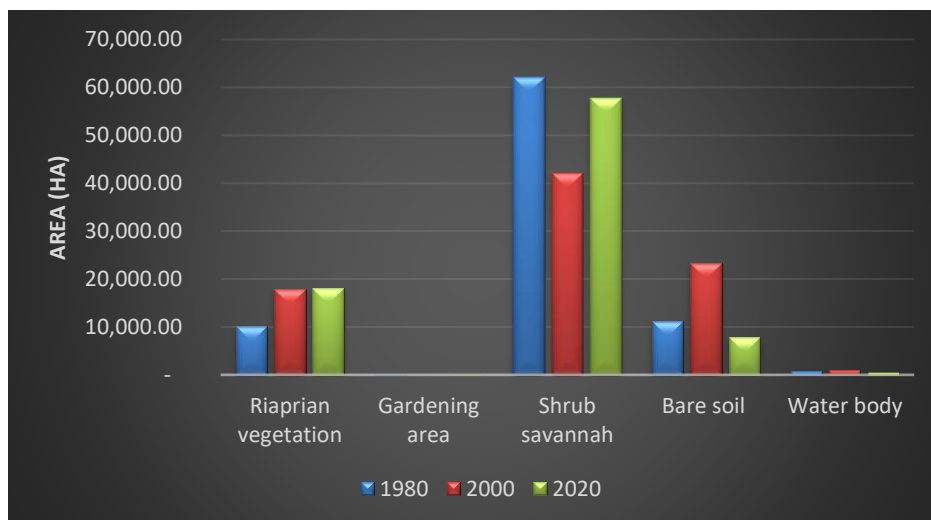
Figure 7 shows the area occupied by land use units for each year. The different units are shown in Figure 8. They concern bare soil, water bodies, vegetation composed of the riparian sheath, shrub savannah and the gardening area of the 1980, 2000 and 2020. Analysis of these shows an increase in the area of water bodies between 1980 and 2000, then its decrease in 2020. These bodies of water are mainly concentrated downstream of the catchment and concern the Mozagué and Nadabar dams. Soil has changed in each year of the study. Thus, an improvement in the area occupied by the riparian sheath over the entire study period is observed in the Maggia. On the other hand, a decreasing trend of shrub savannas was seen in the period 1980 to 2000, leaving bare soil. However, in 2020 the bare soils are decreasing to the benefit of densification of vegetation especially on the right portion. The growing area covers a larger area in 2020 followed by the 1980 and 2000.

Figure 7. Evolution of land use units
