## Assessment of Flexible Pavements of the Road System of the Urucu Petroleum Province/Amazonas/ Brazil

**Carlos Fábio Cortezão Carvalho<sup>1</sup>, Anne Karollynne Castro Monteiro<sup>2\*</sup>, Cláudia Ávila Barbosa<sup>2</sup>, Carlos Eduardo Neves de Castro<sup>2</sup>, Consuelo Alves da Frota<sup>2</sup>**

*<sup>1</sup>Petroleo Brasileiro, UO-AM, Manaus, Amazonas, Brazil <sup>2</sup>Research Group in Geotechnics (GEOTEC), Federal University of Amazonas, Manaus, Brazil*

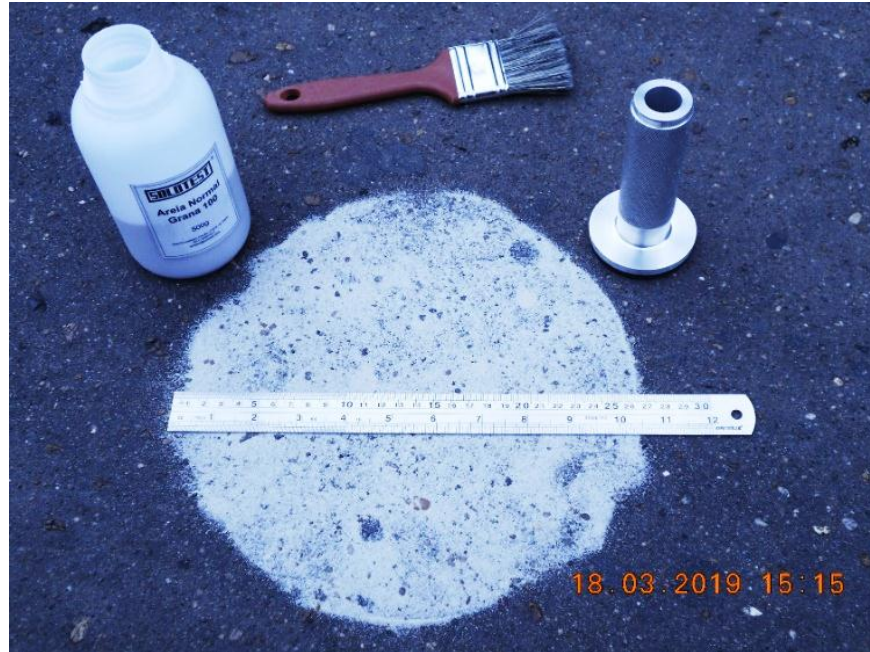
**Figure No. 6: Measurement of the diameter of the scattered sand circle**

A macrotexture survey was carried out for determining the condition of the pavement surface roughness (Figure No.6). This investigation was performed on surface spots not displaying any cracking or significant defects.

During the experiment, we observed that the section revealed periodic maintenance. Hot Mixed Sand-Asphalt (HMSA) patches were made. Such a solution is identified as a formulation without the presence of coarse aggregates in its composition, which leads to a microtexture to Asphalt Concrete (AC). In determining the average depth of the macrotexture ( $H_s$ ), we proceeded the same way. There was no separation by subsection, that is, all spots were considered. However, in the locations where the replacement of the AC coating with HMSA had been carried out, a reduction in the average of  $H_s$  values is noticed. These different spots are positioned below the line (0.40) (Figure No. 7).
